Archaeological Testing Report

Sweeney's Orchard

Kilkenny City

Licence: 18E0213

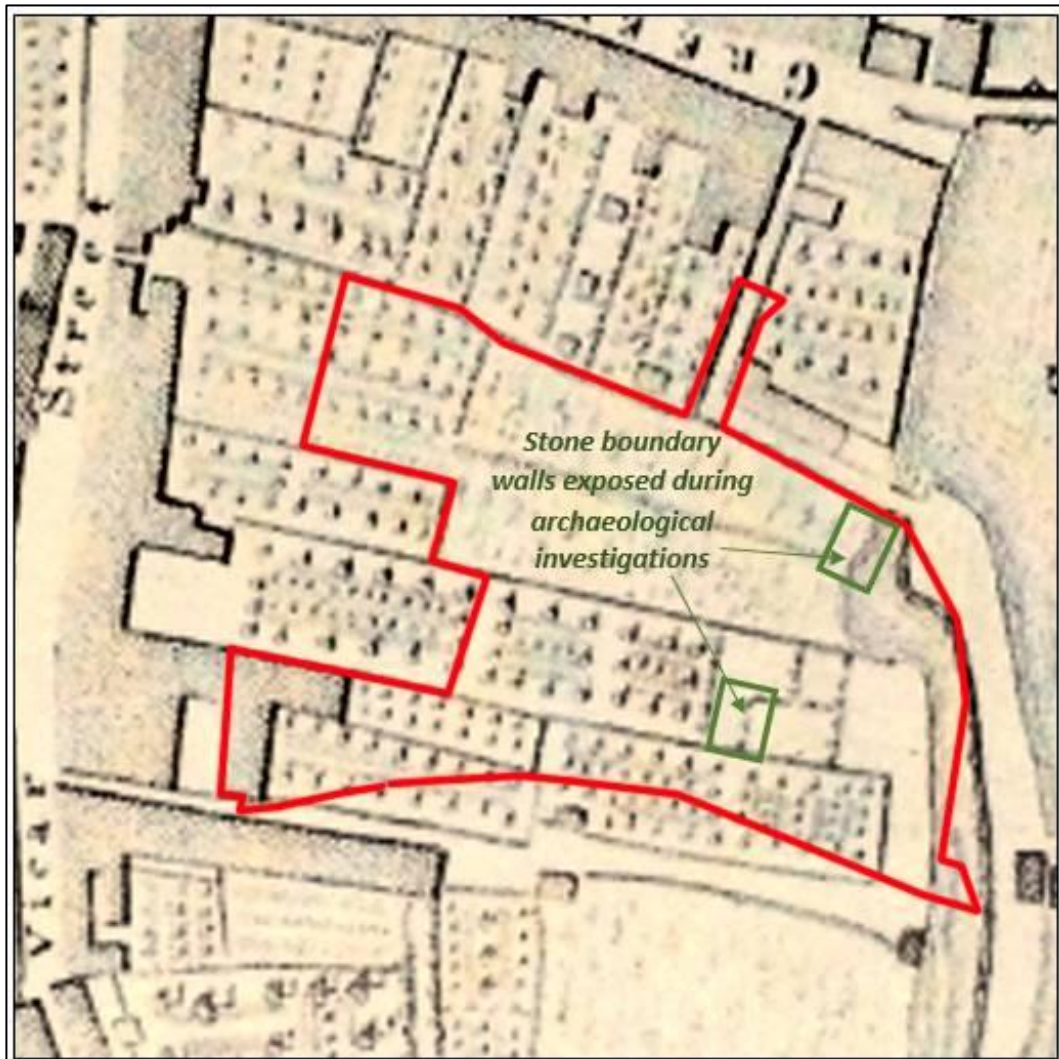
Figure 5. Inset from John Rocque's 'Map of the City of Kilkenny' (1758); the stone walls uncovered during testing are depicted in green.

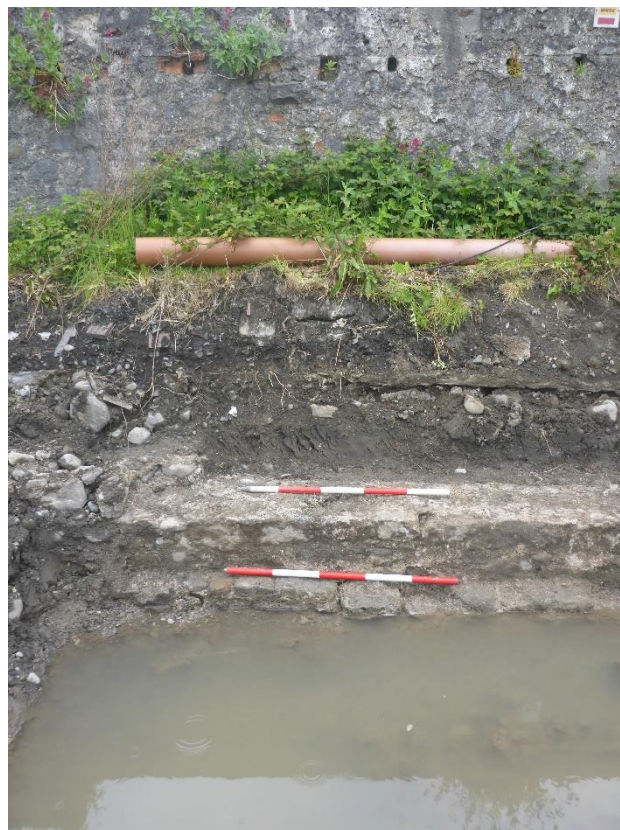
Plate 6. Western-end of Test Trench 5 with detail of wall, facing north.

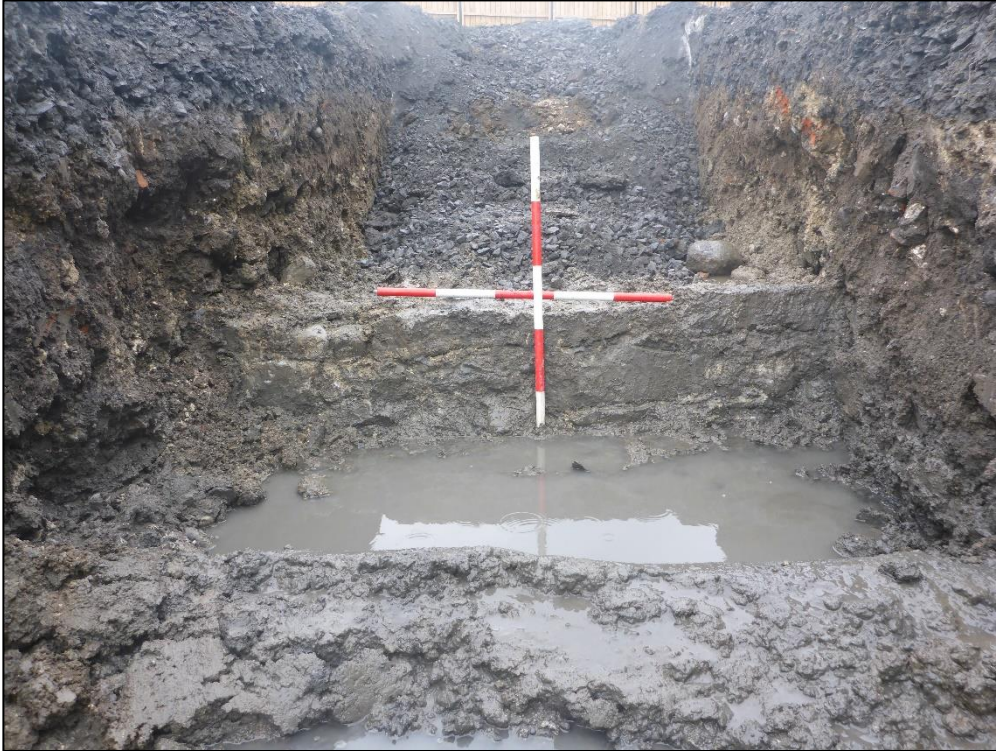
Plate 9. Detail of wall in Test Trench 7, facing south.

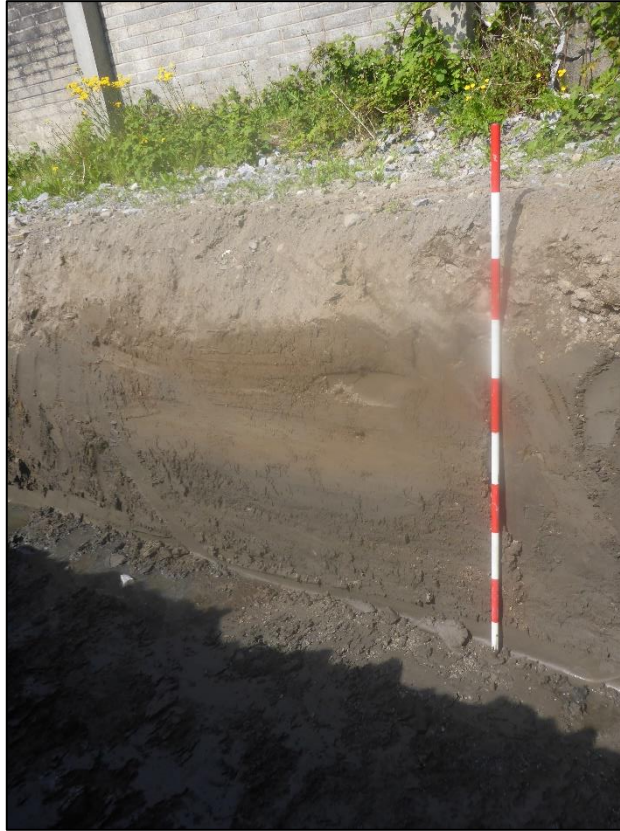
Plate 11. Detail of stratigraphy in Test Trench 8, Facing east.

Trench	Dimensions	Findings
Trench 8	27m (N-S) x 2.20m (E-W) 1.80m–2.20m deep Water table at 1.80m BGL Plates 10 and 11	The uncovered deposits in Trench 8 were demonstrably different to those noted within the western half of the site (Table 10). The water table was not encountered until a depth of 1.80m BGL, which is remarkable given its proximity to the River Nore. It is possible that the clayey silt (C19) was representative of a fill associated with a former millrace; however, no evidence of an associated cut was identified. The eastern-ends of Test Trenches 3 and 4 from 2007 ¹⁶ were also encountered within the southern half of the trench (see Figure 4).
Trench 9	6m (N-S) x 2.20m (E-W) 1.80m deep Plate 12	The trench was backfilled with a mix of modern refuse, rubble and plastic. It was eventually abandoned at a depth of 1.80m, as the disturbed deposits were unstable and dangerous.
Trench 10	12m (N-S x 2.20m (E-W) 2m–2.40m deep Water table at 2m BGL Plate 13	The trench uncovered the remains of a substantial ditch [C26] in the southern-end of the trench at a depth of 1.40m BGL. The feature was cut into the garden soil (C23) (see Table 12) and was investigated to a depth of 2.40m BGL; however, the excavation had to be stopped as the sondage quickly filled with water (Plate 13). The width of the ditch at this level (2.40m BGL) was 1m and it was still extending downwards. [C26] was filled with a charcoal-rich dark greyish brown silty clay (C27). It incorporated <8% sub-angular and sub-rounded stones and pebbles, as well as moderate burnt clay inclusions. No artefacts were recovered that might suggest a date or function for the feature.

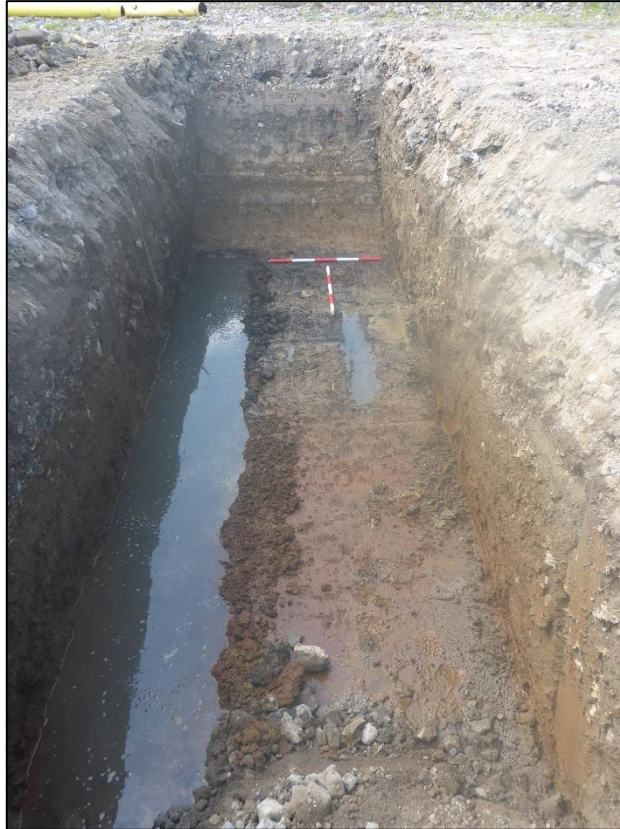
Plate 13. Overview of Test Trench 10, facing south. The extent of the ditch is indicated by the ranging rods.

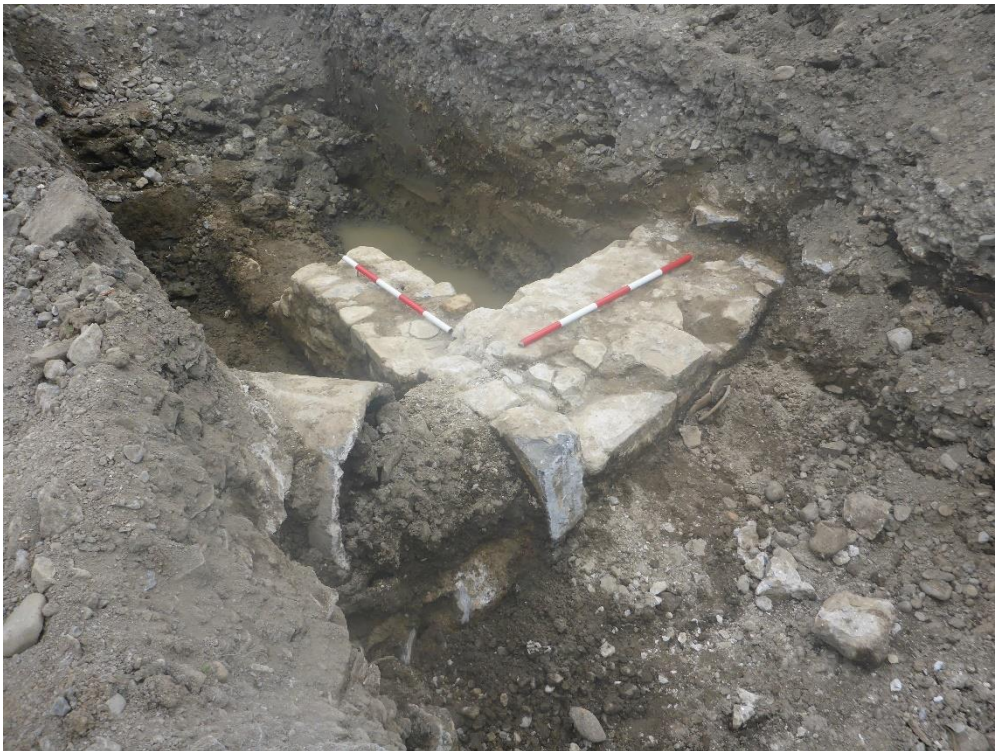
Plate 16. Disturbance to wall in Test Trench 11 from modern concrete pipe, facing northwest.

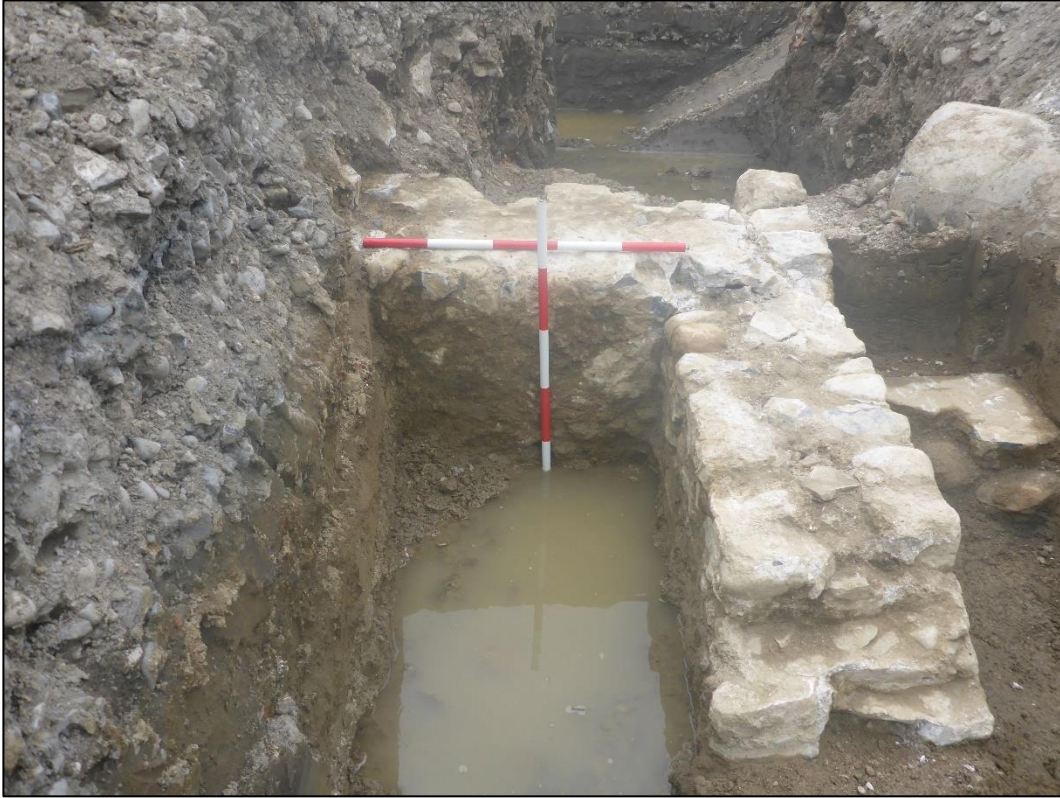
Plate 17. View of wall in Test Trench 11, facing east.

A mortar sample was examined from a wall revealed in Trench 11 as it was thought that the structure may be medieval in date and possibly associated with the city’s defensives. Analysis of the mortar found that the sample was not suitable for radiocarbon dating, however it is likely to be post medieval (Bolton 2018) as the following indicators were present in the sample:

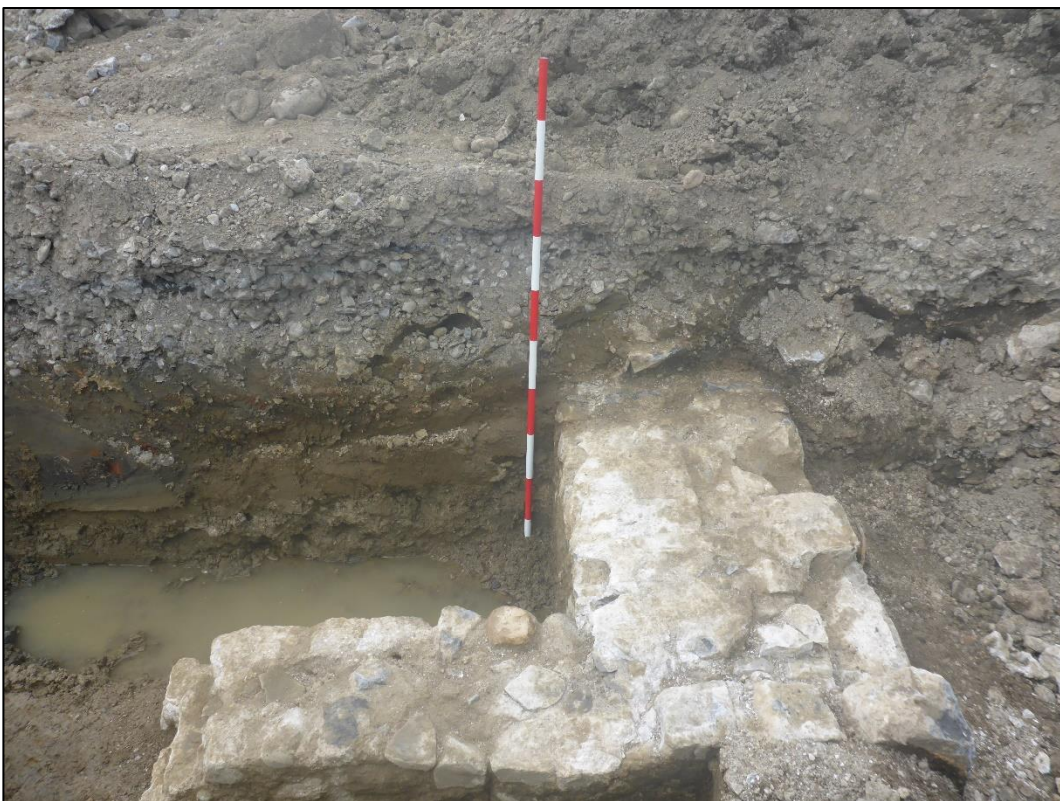
Plate 18. Detail of undisturbed stratigraphy to west of wall in Test Trench 11, facing north.

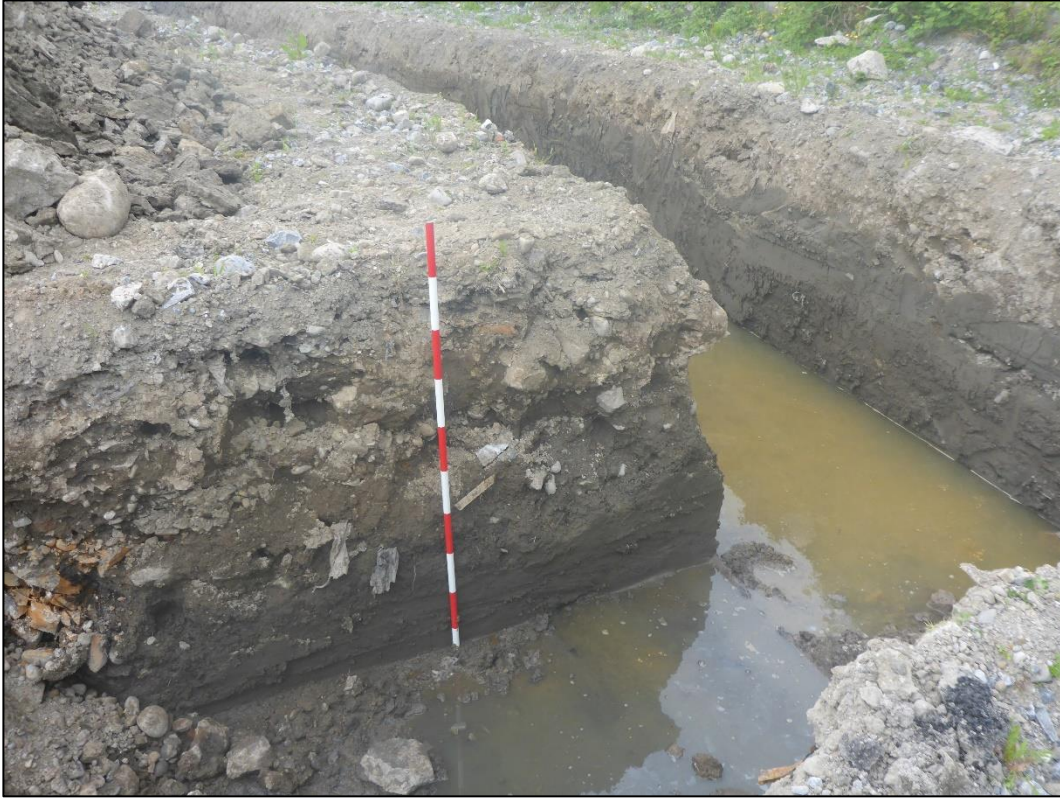
Plate 19. Detail of disturbed deposits to east of wall in Test Trench 11, facing northeast.

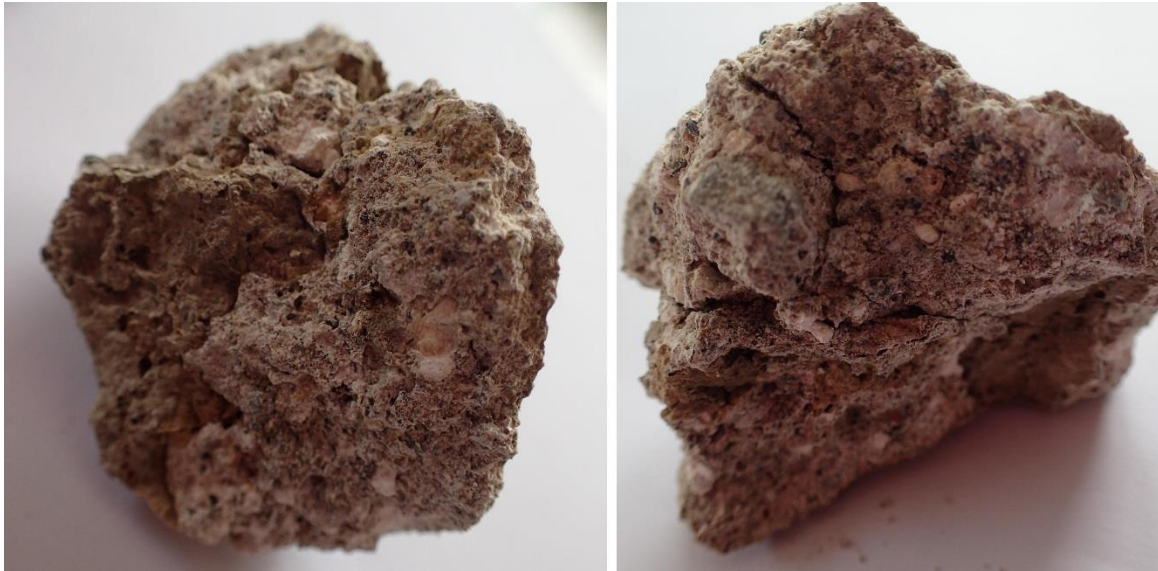
Above: View of mortar from Sweeney's Orchard in hand sample. Note the formation of a separate layer (left) on the underside through redistribution of the lime.

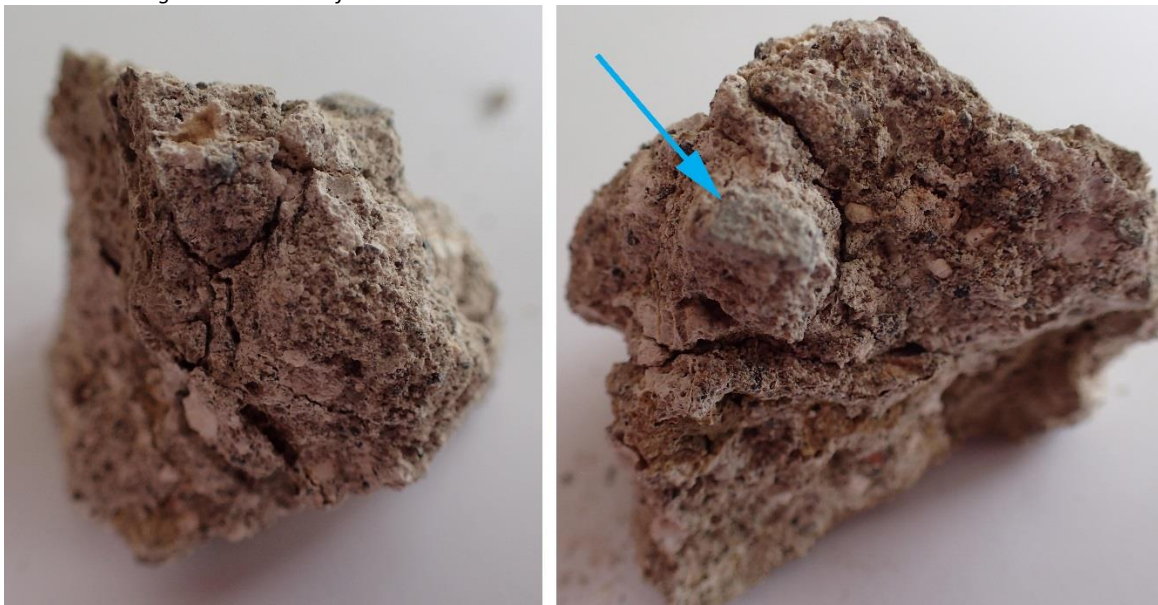
Above: View of mortar sample showing cracking, whitish 'lime lumps' & recrystallised lime (arrowed).

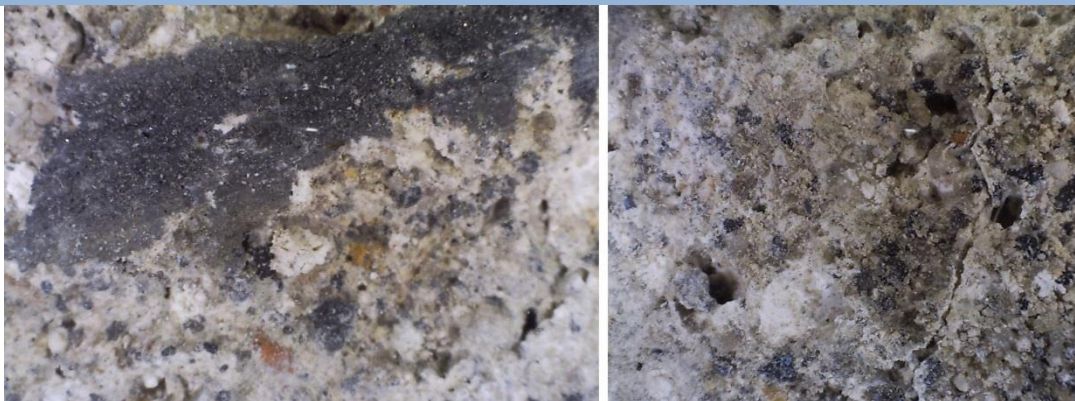
Above: Microscopic view of the mortar showing lime lumps and poorly sorted aggregate in a lime binder matrix (left). Open cracks are commonly seen (right).

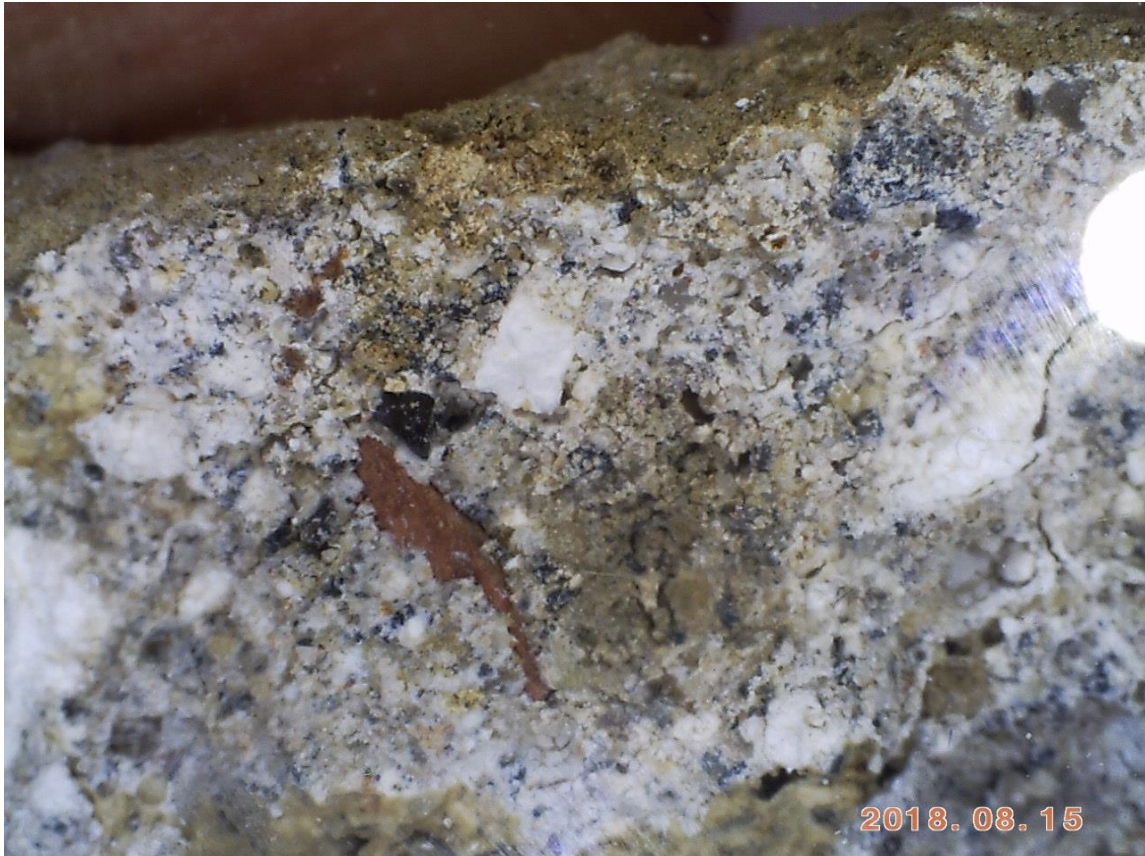
Above: Microscopic view of the mortar showing fine aggregate & an angular ceramic fragment (pozzolan, arrowed).

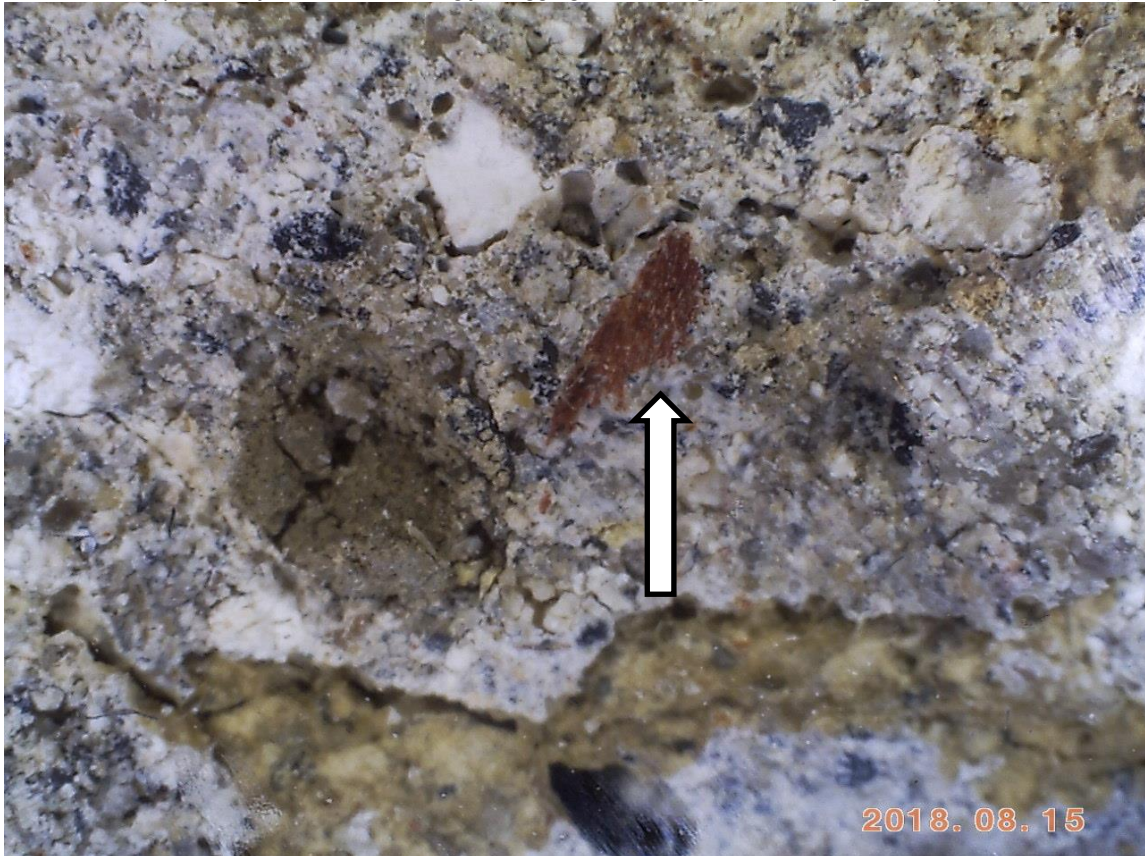
Above: Microscope detail showing clay (brown & yellow-brown) and a ceramic fragment (pozzolan, arrowed).

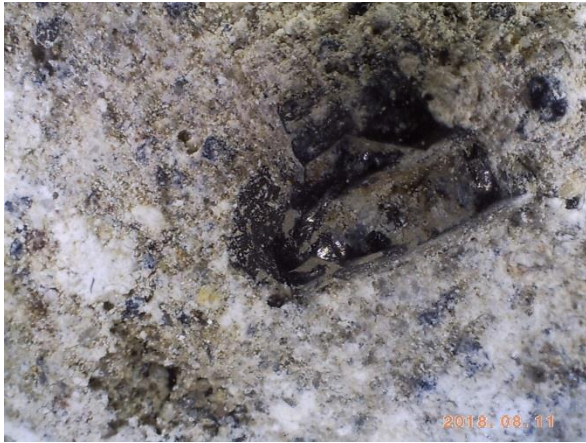
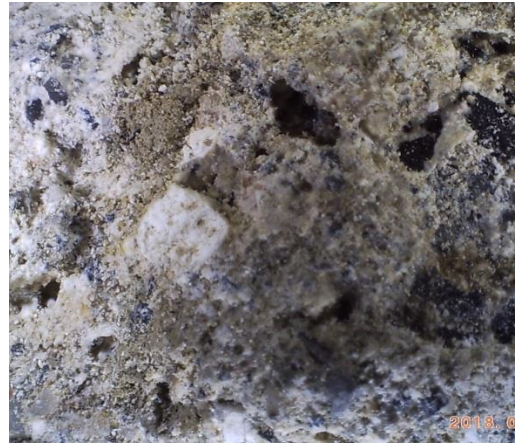
Above: Burnt fuel fragments which appear to be coal.

Coal was used – this is common in post-medieval samples, while timber, peat and charcoal are more often found in medieval samples¹⁶.

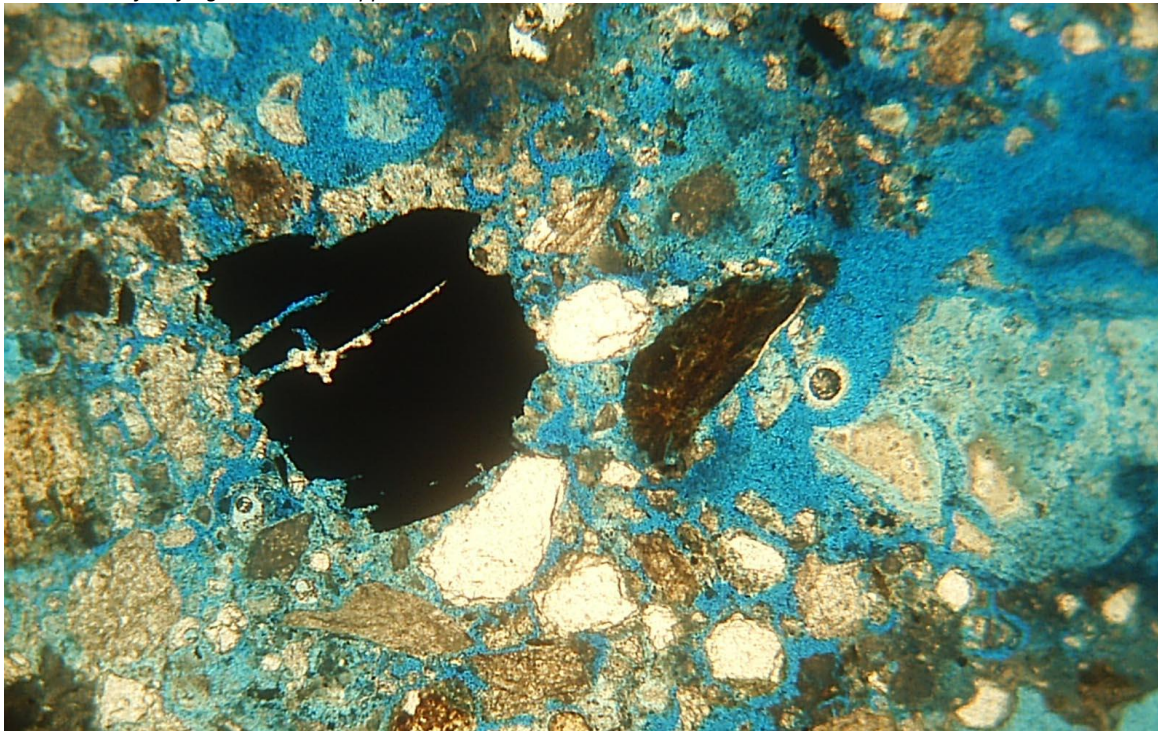
Above: View of Thin Section #1 showing a weathered lime-based mortar with enhanced porosity and a burnt fuel fragment¹⁵.

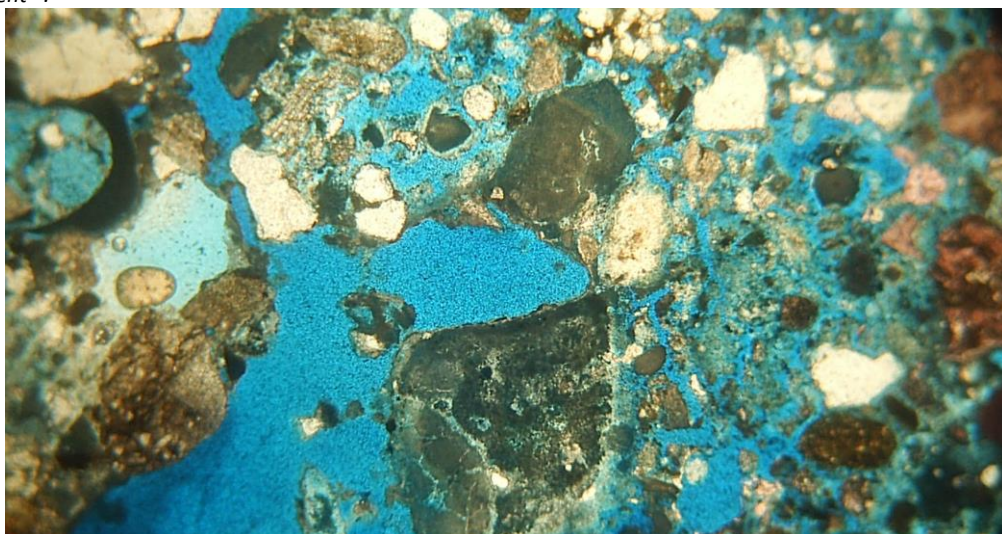
Above: Much of the mortar shows enhanced porosity (blue areas) which suggests prolonged weathering

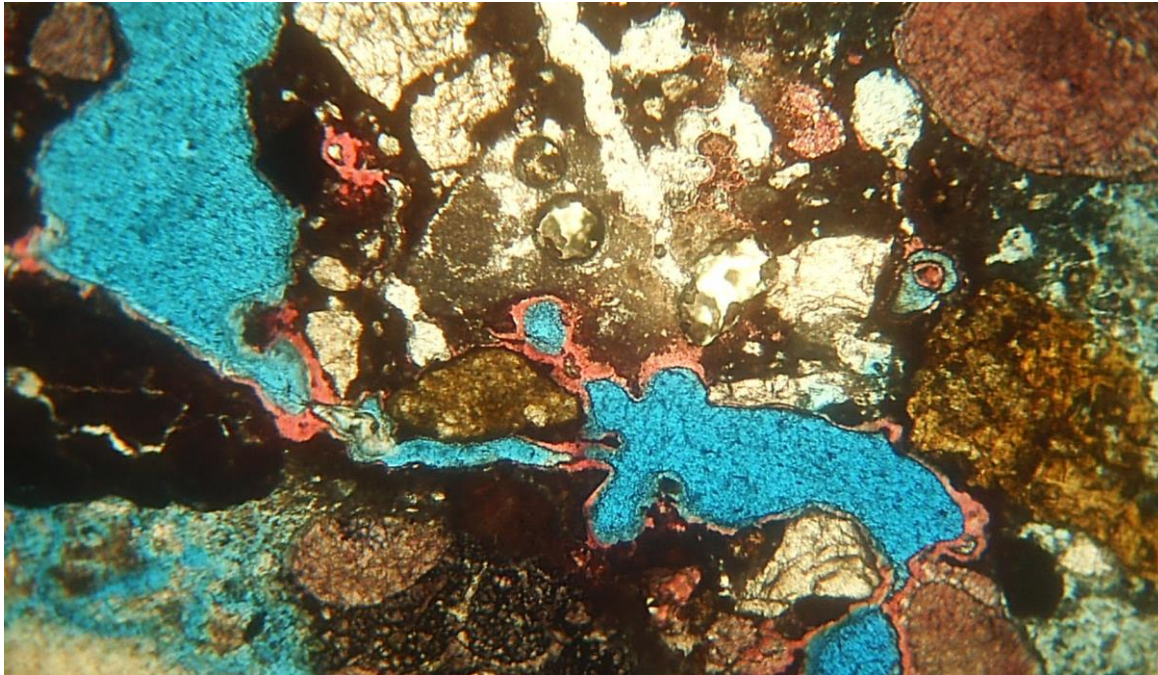
Above: Detail of a pore showing recrystallised lime (pinkish) lining the pores.

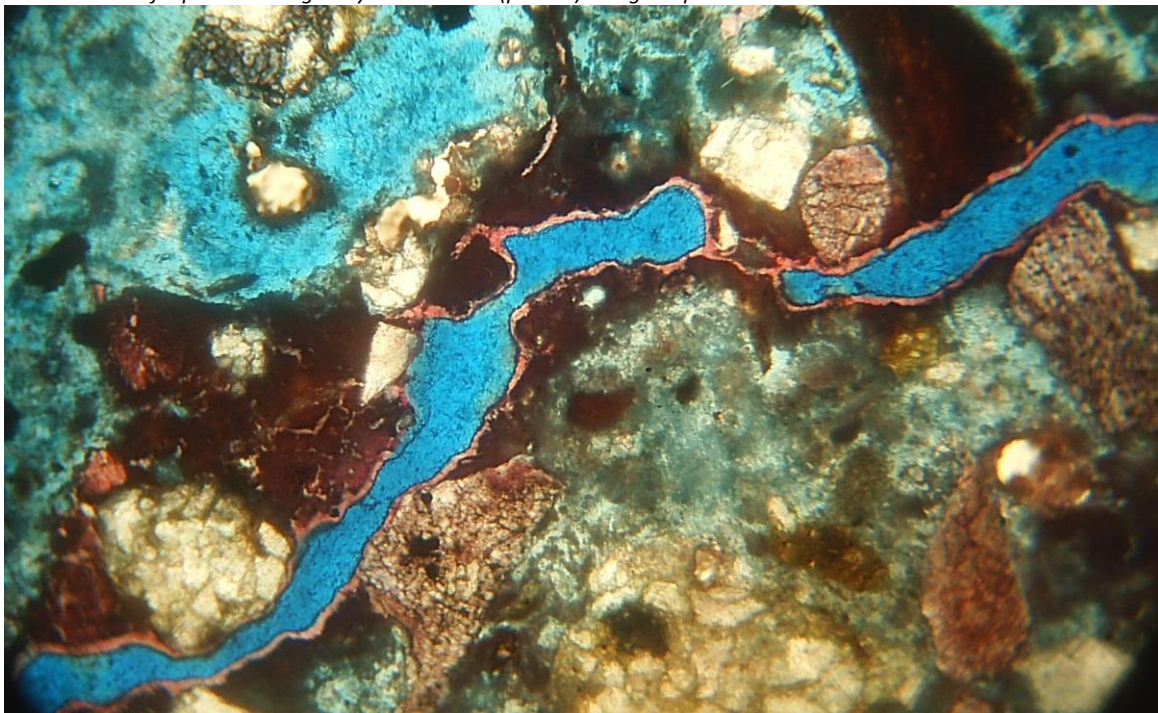
Above: Detail showing recrystallised lime (pinkish) lining the pores.

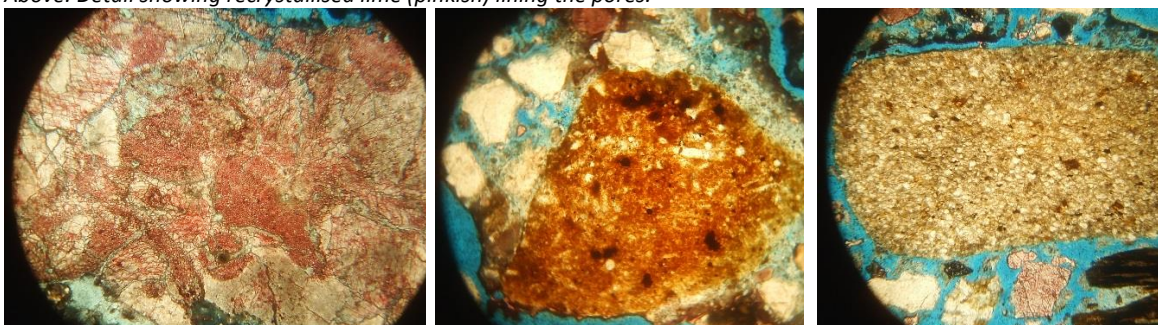
Above: The aggregate consists of a range of lithics including fossiliferous and other limestones, chert, sandstone, siltstones

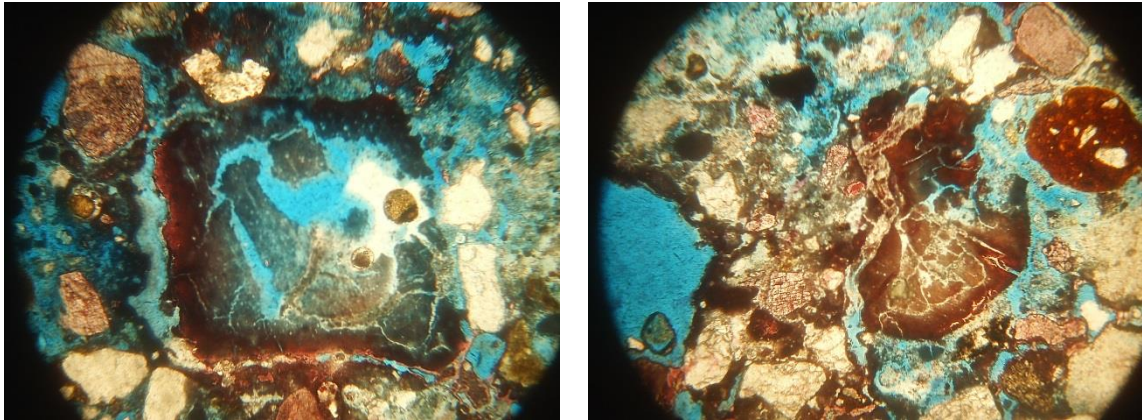
Above: Fractured 'lime lumps' now form part of the aggregate fraction of the mortar.

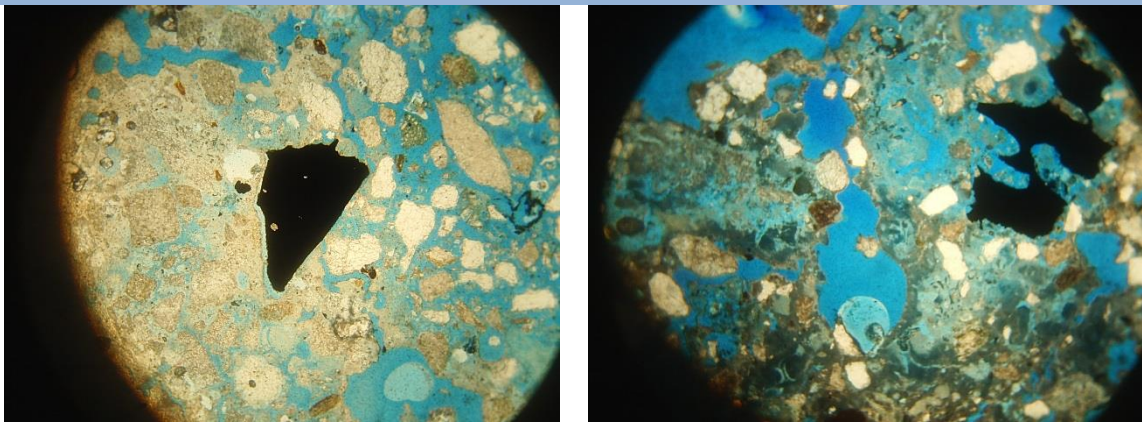
Above: The mortar shows enhanced porosity (blue) and coarse fuel fragments (black).

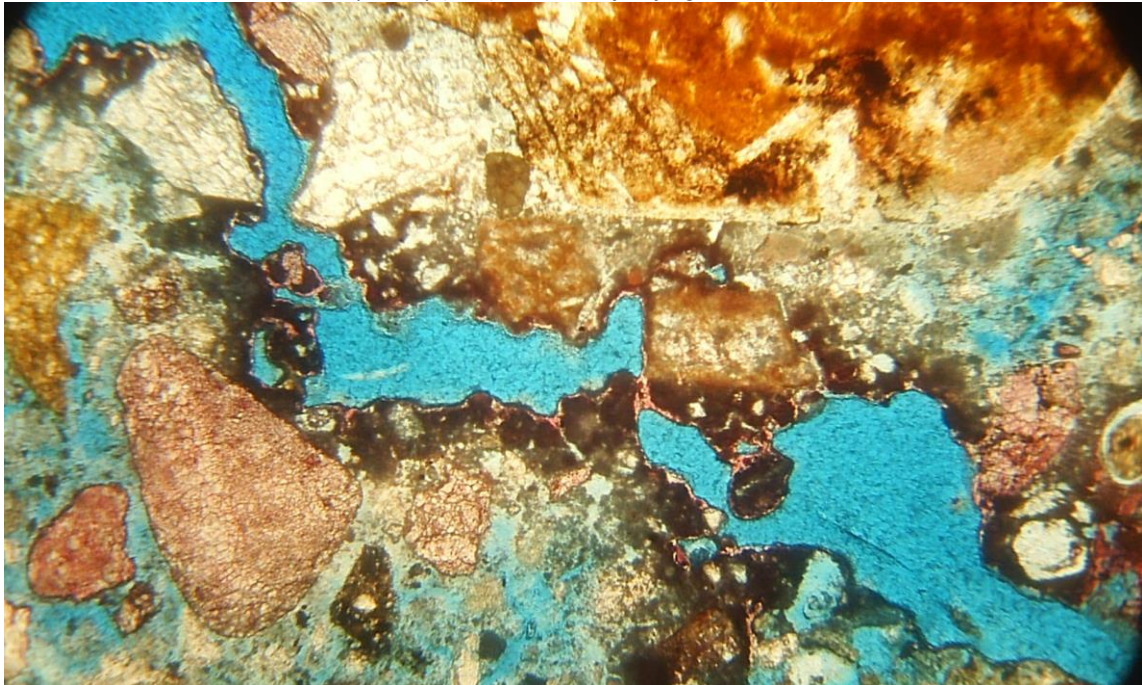
Above: Detail showing recrystallised lime (pinkish) lining the pores, with poorly sorted aggregate of limestone, chert and other lithics supported by a lime binder matrix.

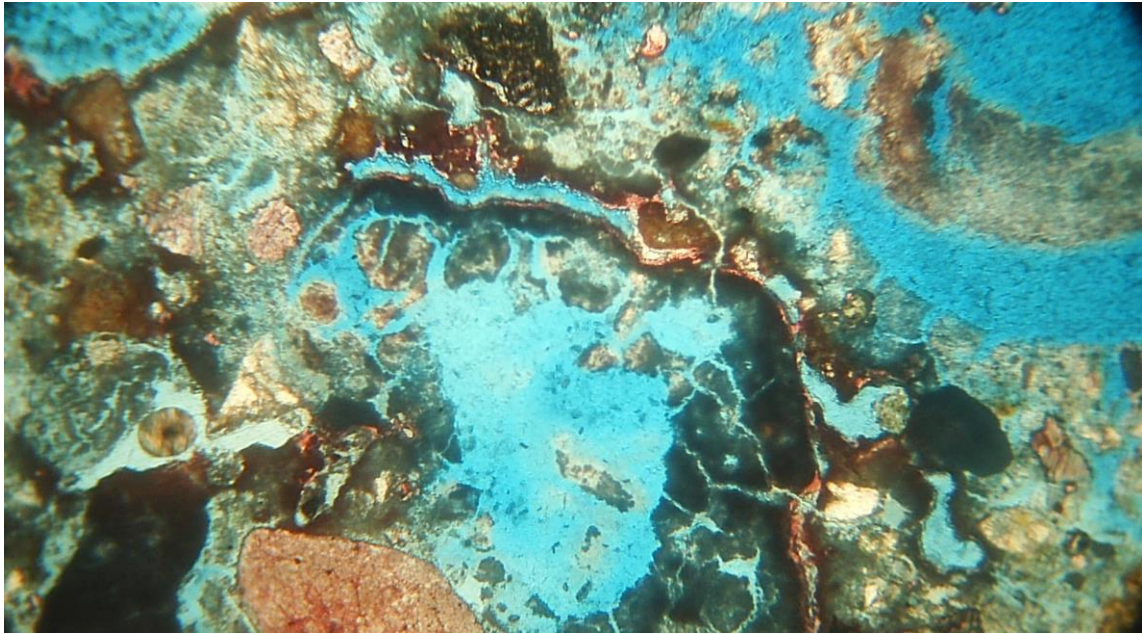
Above: Detail of Sample #2 showing recrystallised lime lining the pores.

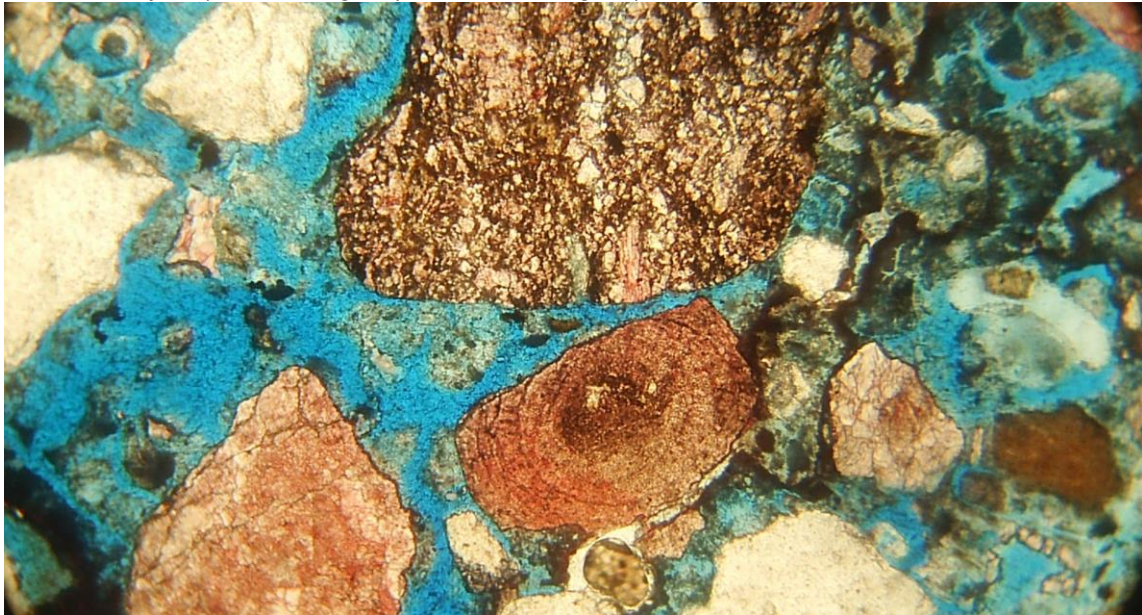
Above: Limestone predominates among the aggregate component of the mortar

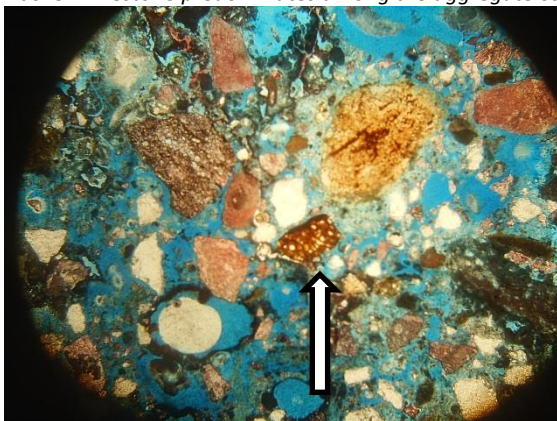
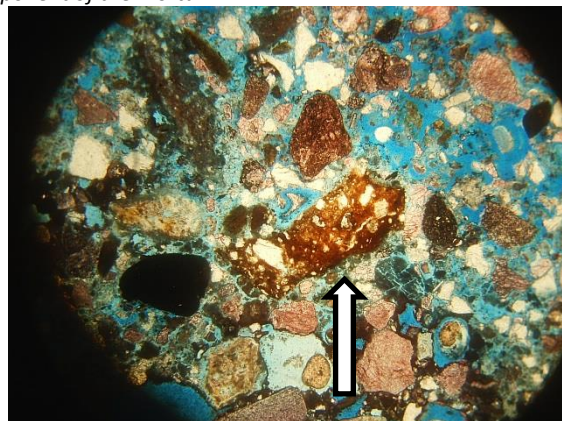
Above: The sample contains burnt ceramic fragments – brick dust was often added to post-medieval mortars as a pozzolan to provide a hydraulic set to the mortar.

Brick/ceramic fragments were used – these are commonly found in post-medieval mortars. While brick is a taxable commodity from the 13th century in Ireland, brick does not occur in the archaeological record until the sixteenth century, with the earliest brick dating to 1505 AD in Dublin¹⁷. Brick was used for specialised purposes towards the end of the 16th century, but only came into more widespread use in Ireland from the 18th century onwards. While Kilkenny had high quality limestone masonry, the clay in the surrounding hinterland was suitable for making quality brickwork. Bricks were used in post-medieval buildings for wall linings and for their precision in the construction of building elements such as chimneys, dressings, window openings and creating pockets for floor joists. The waste from this activity (crushed brick) was then incorporated into mortars as an additive to improve setting and durability. This means that as brick pozzolan is found in the mortars from the wall in Trench 11, the mortar should be considered post-medieval.

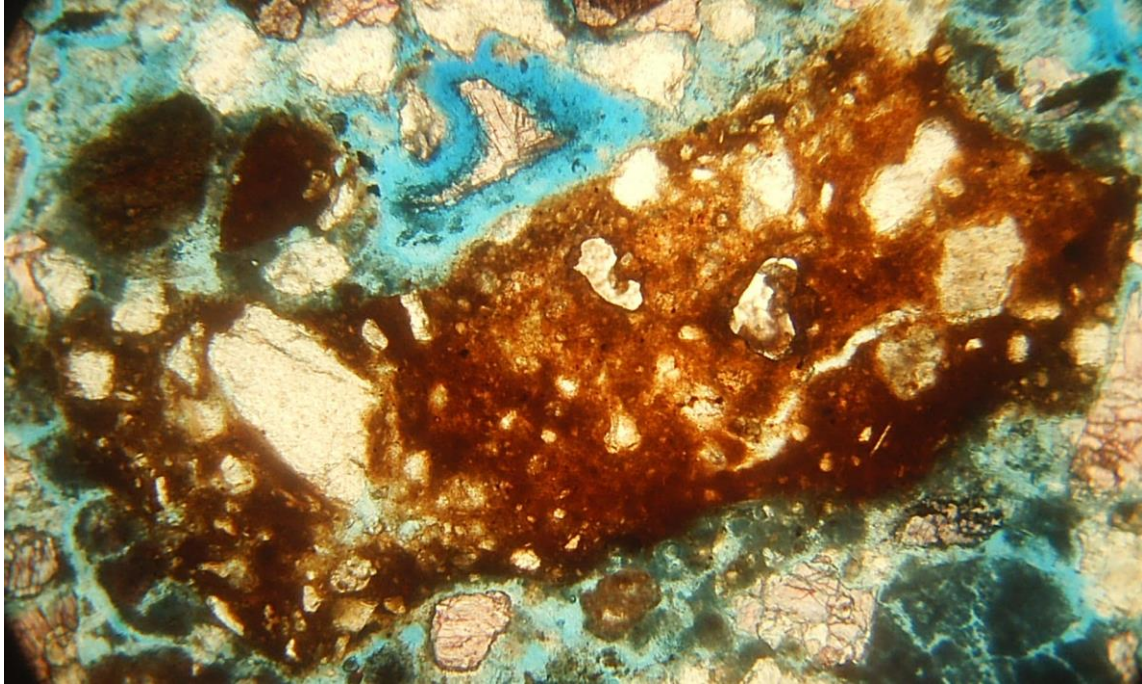
Above: Detail of a brick fragment acting as a pozzolan.

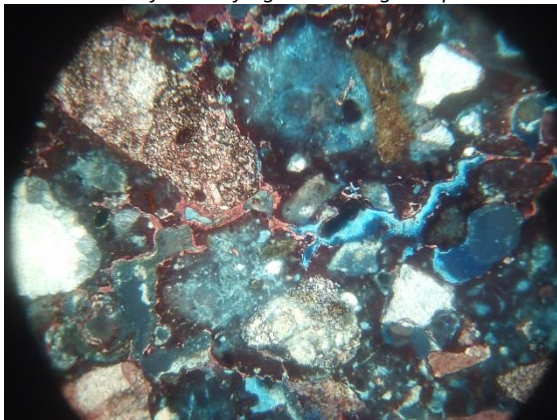
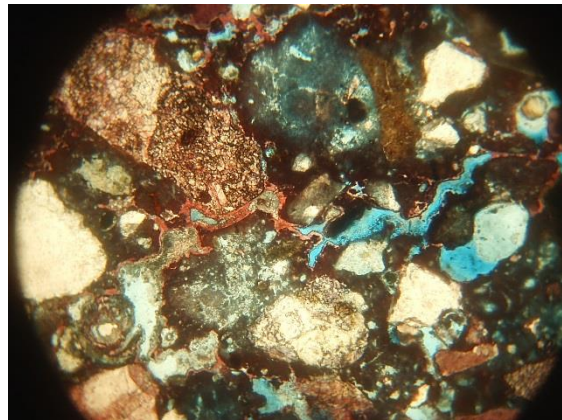
Above: General view of the mortar showing enhanced porosity, poorly sorted aggregate composed of a range of different stone types, and recrystallised lime lining the pores.
